The Commonwealth of Massachusetts
Executive Office of Health and Human Services
Department of Public Health
Bureau of Environmental Health Assessment
250 Washington Street, Boston, MA 02108-4619

May 2, 2000

Marge McGrath, Principal
Dolbeare Elementary School
340 Lowell Road
Wakefield, MA 01880

At the request of the Wakefield Board of Health, an indoor air quality assessment was done at the Dolbeare Elementary School, in Wakefield, Massachusetts by the Massachusetts Department of Public Health (MDPH), Bureau of Environmental Health Assessment (BEHA). Reports of headaches and respiratory symptoms attributed to sewer gas odors prompted this request.

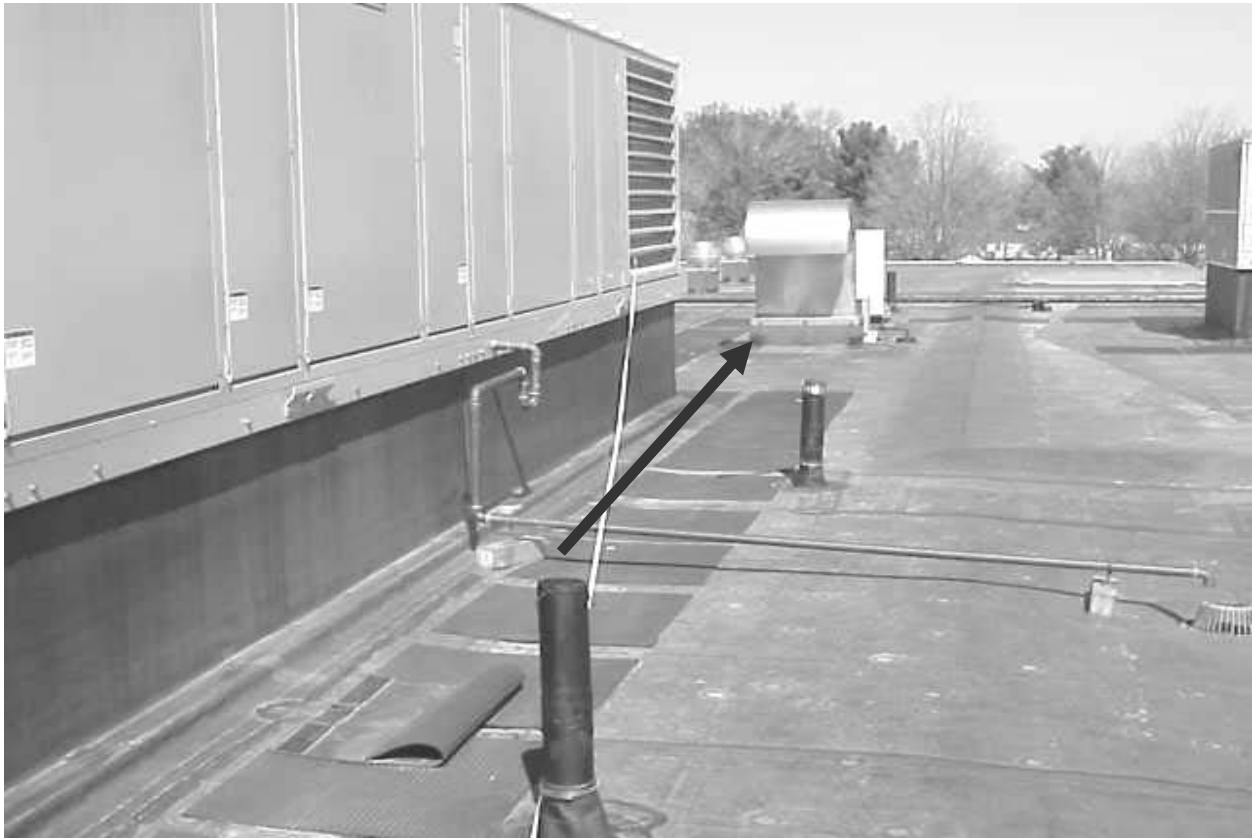
Picture 1

1. the close proximity of sewer gas vent pipes to rooftop air-handling equipment (see Picture 1);
2. reports of odor complaints coincided with times of increased restroom usage and;
3. the isolation of odor complaints to areas solely serviced by rooftop air-handling equipment

**Sewer Gas Vent Pipes Noted on Roof Downwind from AHU
Arrow Indicates Wind Direction the Day of the Assessment (3/23/00)**

1. Uncap and extend vent pipes in close proximity to air-handling equipment. The building code requires that pollutant sources must be ten feet away from and two feet above fresh air intakes (BOCA, 1993, SBBRS, 1997). An extension several feet above the fresh air intake may be needed to prevent sewer gas entrainment.
2. Consider contacting the building architect and town inspectional services to assist in the identification of possible sources of sewer gas odors (e.g., HVAC systems, maintenance closet sinks, rest room floor drains, unused/broken sinks and/or water fountains, etc.).

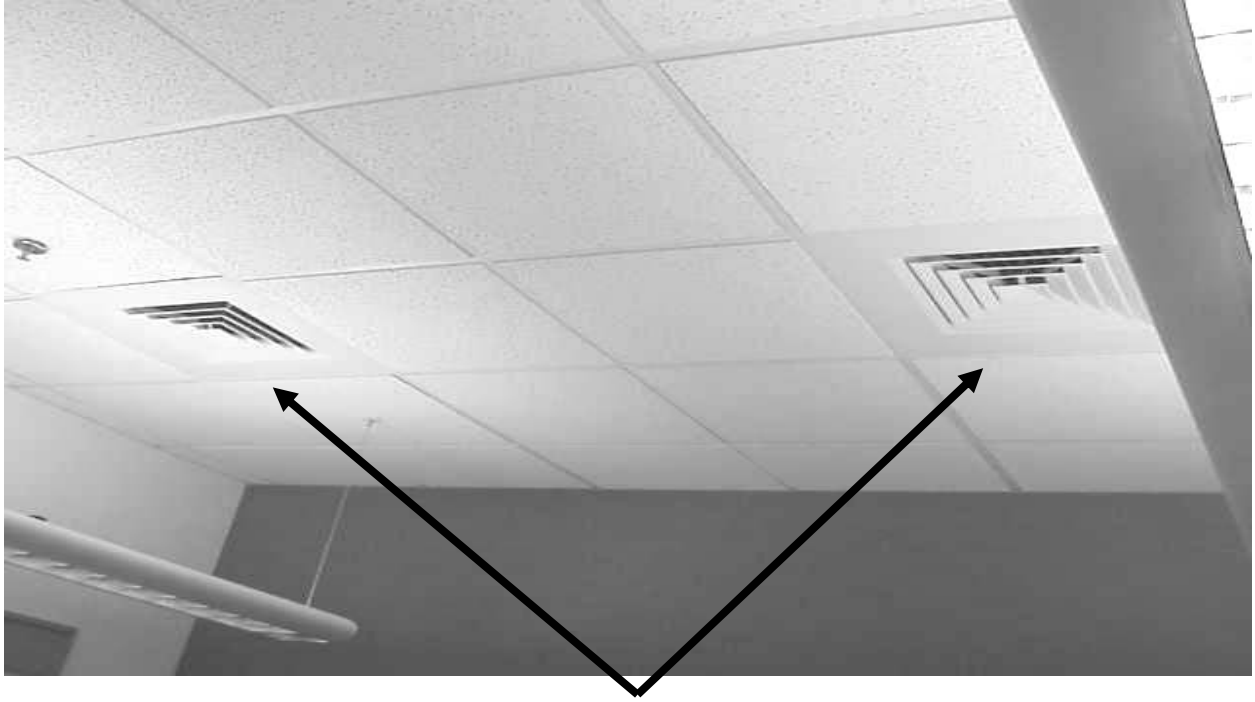
Picture 2

It was believed that the odors were being distributed into the building via ceiling-mounted air diffusers located directly above the reception desk (see Picture 2). These air diffusers are connected to the rooftop air-handling unit (AHU) via ductwork. To support this theory, BEHA staff conducted a visual inspection of the roof and noted two sewer gas vent pipes in close proximity to the AHU (see Picture 1). The close proximity of these vent pipes to the AHU, in combination with certain weather conditions, can lead to sewer gas being drawn into the fresh air intake (called entrainment) and distributed to occupied areas in the building. The closest vent pipe was capped and was located approximately six feet diagonally from the AHU's fresh air intake (see Pictures 3 & 4).

**Ceiling-Mounted Air Diffusers, Connected to Rooftop AHU in the Main Office
(Secretaries Area)**

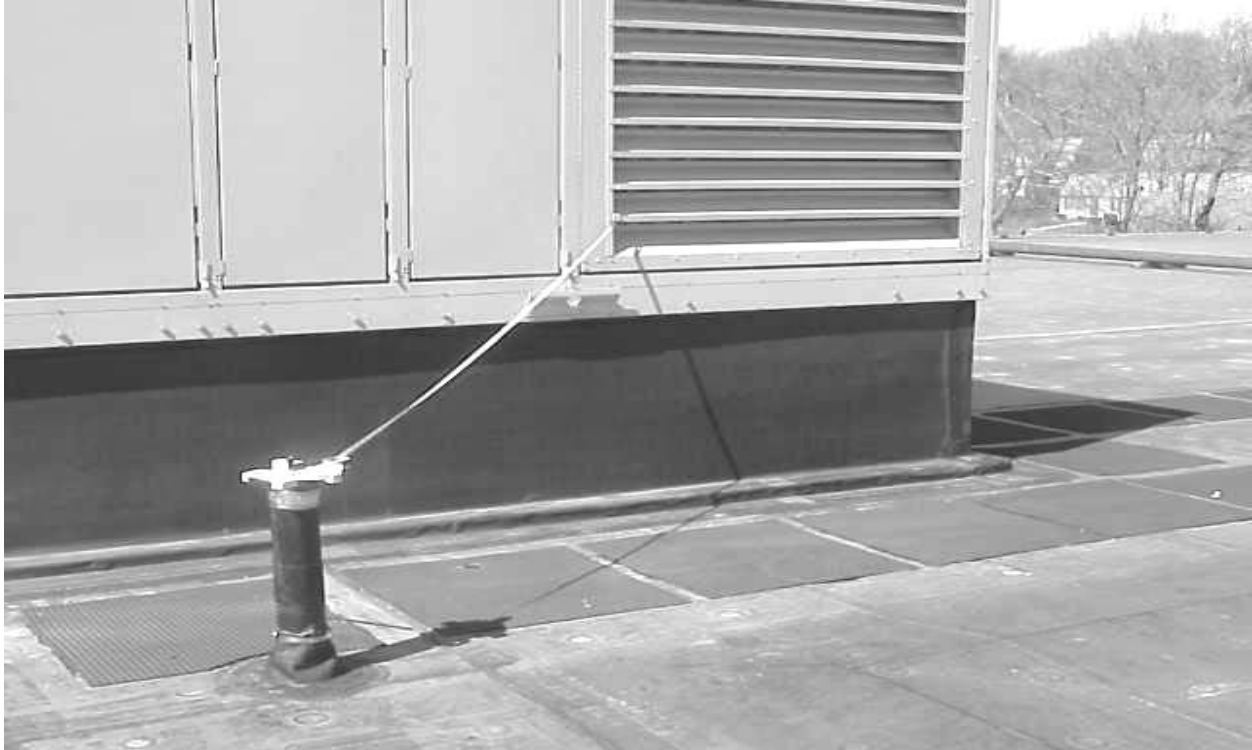
Picture 3

It was believed that this vent pipe was capped originally to prevent the entrainment of sewer gas into the fresh air intake. However, the capping of the vent pipe can create a pressure buildup resulting in the back up of sewer gas odors. It is also important to note wind conditions on the day of the assessment. During the visit Southwest winds of 2-5 MPH were measured, conditions on the roof were noted to be such that any sewer gas being vented would be directed toward the fresh air intake (see Picture 2).

Sewer Gas Vent Pipe in Close Proximity (~ six feet) to AHU Fresh Air Intake

Note Vent Pipe is Capped

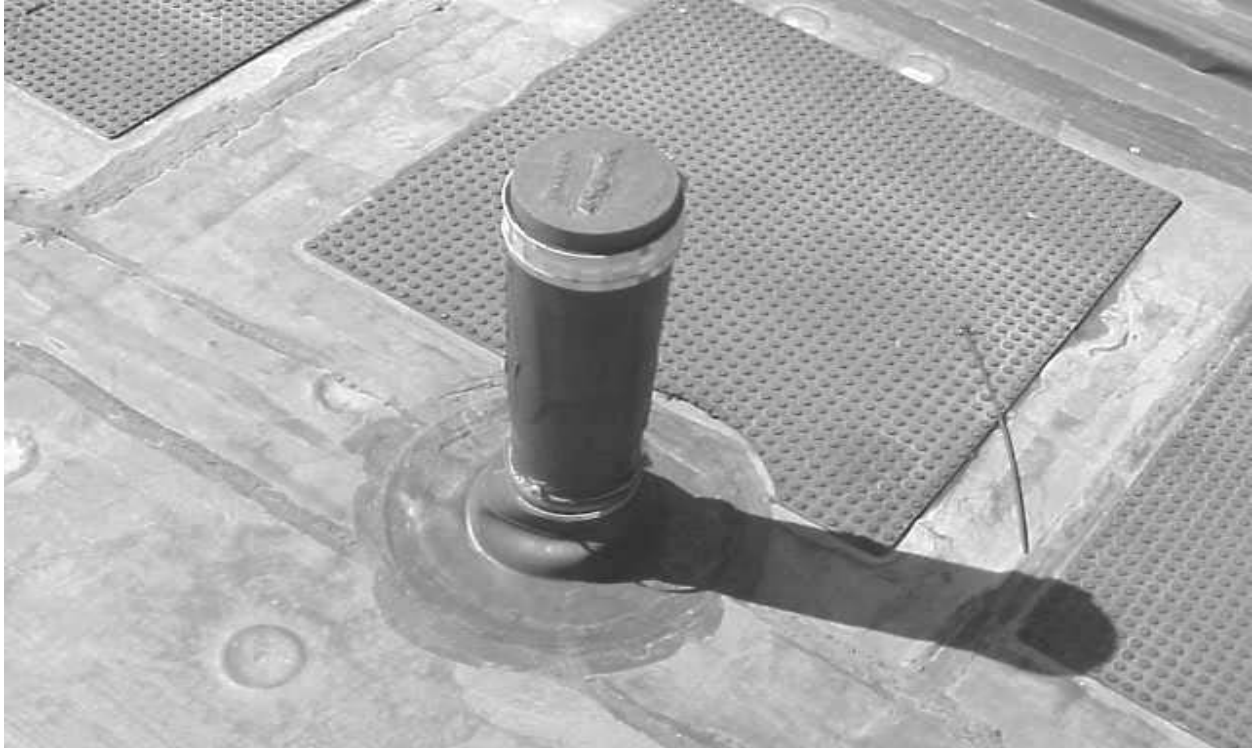
Picture 4

Capped Sewer Gas Vent Pipe Noted near AHU Fresh Air Intake
